Manhole Inspection Summary

Manhole # S03UU1005MH

Insp Date: **10/16/06 10:44 PM**

Location Address: **5750 PARK HEIGHTS AVE**

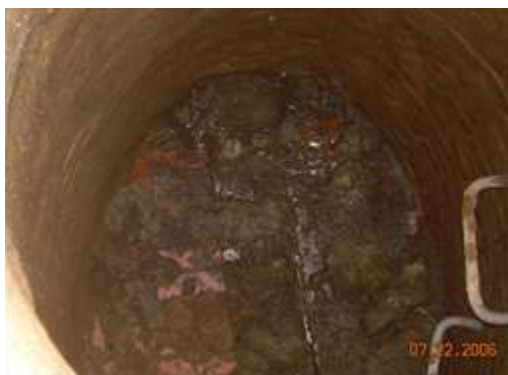
Defect

Frame leaks. Adjustment deterioration and infiltration. Corbel and Barrel infiltration. Corroded steps. 10.16.06

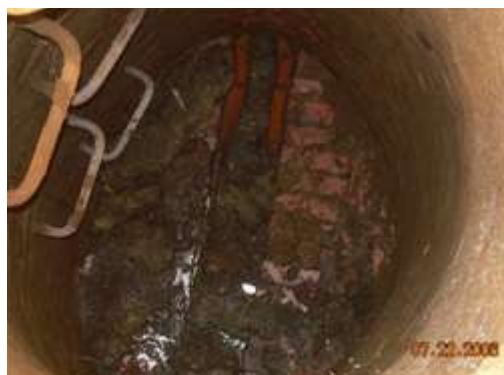
Defect

Evidence of surcharge - Bench debris. Channel debris.

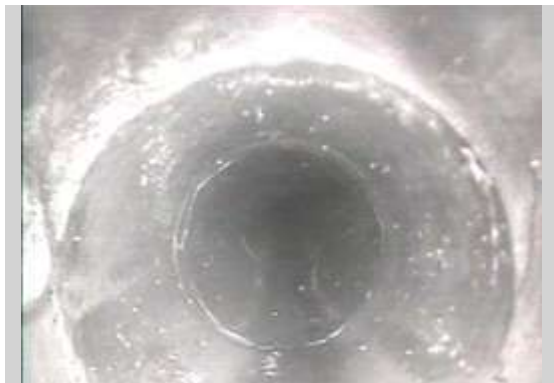
Pipe Out @ 12 O'Clock

8 in. Circular Gravity Sewer

Infiltration: **Evidence** Pipe Seal Cond: **Cracked**

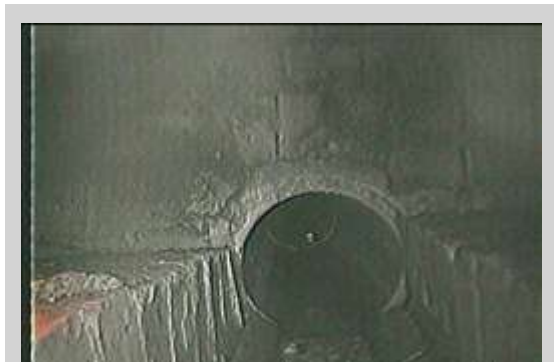
Pipe In @ 6 O'Clock

8 in. Circular Gravity Sewer

Infiltration: **Evidence** Pipe Seal Cond: **Unknown**
